Precast Concrete Panel Systems for Full-Depth Pavement Repairs Field Trials

PUBLICATION NO. FHWA-IF-XX-XXX

FEBRUARY 2007

1. Report No. FHWA-		2. Government Accession No.		3. Recipient's Catalog No.	
4. Title and Subtitle Precast Concrete Panel Systems for Full-Depth Pavement Repairs: Field Trials				5. Report Date February 2007

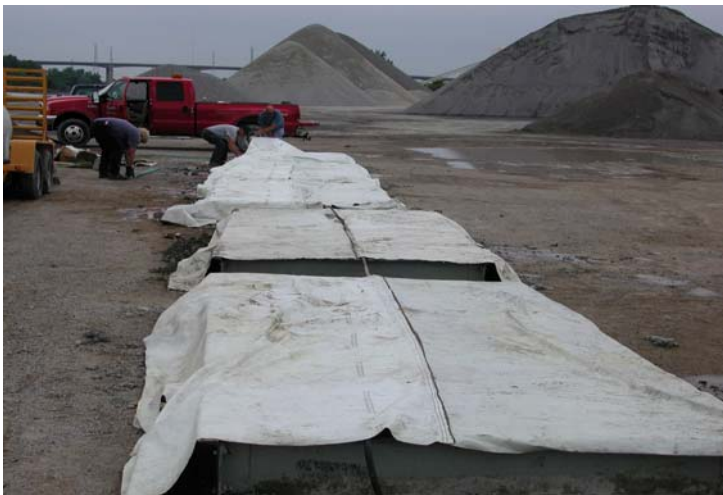
d) Curing of precast slabs.

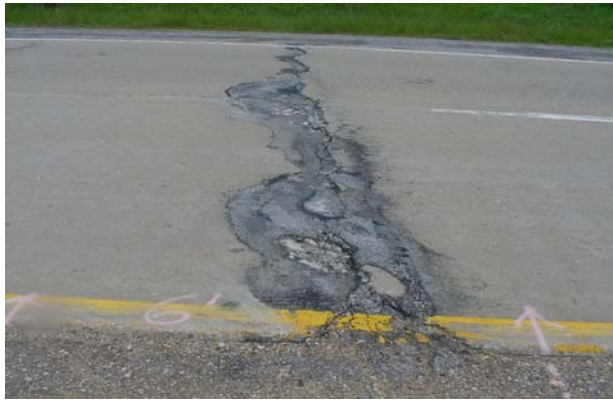
a) Deteriorated joint with cold patch with spalling.

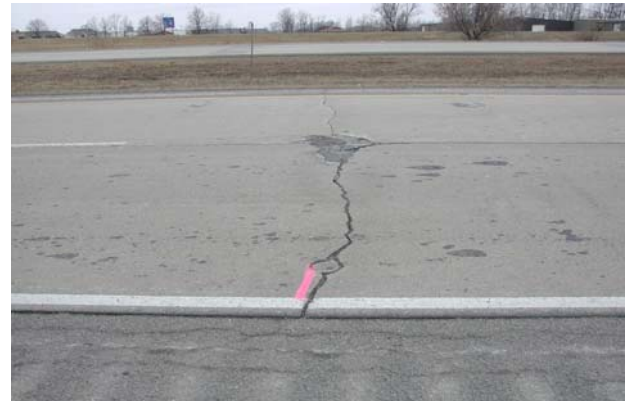
b) Medium-severity transverse crack.

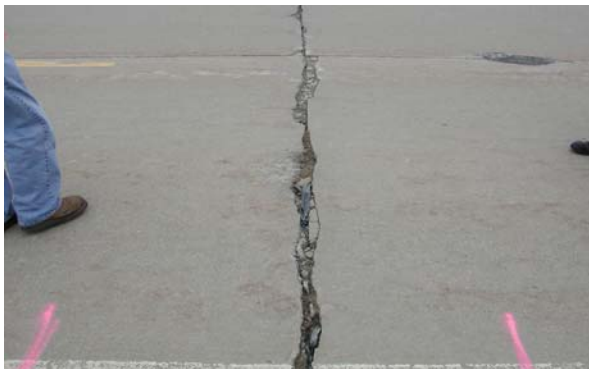
c) High-severity transverse crack.

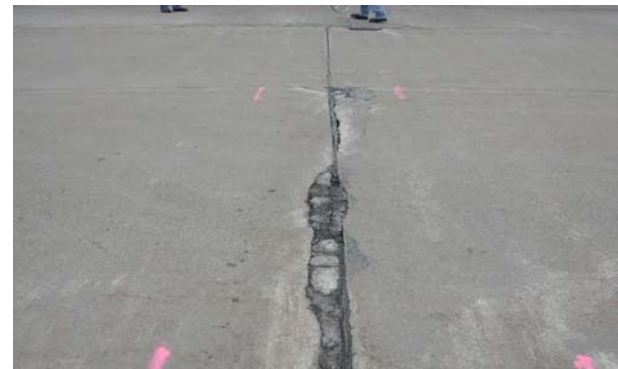
d) Deteriorated joint with spalling.

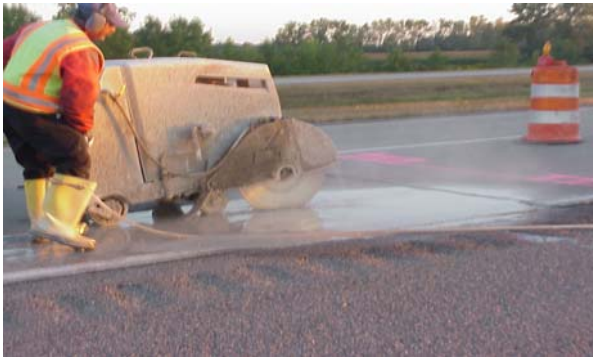
a) Sawcutting the existing slab.

The candidate repair sections were identified and marked by the MDOT personnel (Bay City and Cass City TSC). The slab boundaries were outlined by the contractor and sawcut. The limits of the pavement area to be removed were sawed in the transverse direction. Following the sawcutting operation, the lift hooks were inserted and the distressed slabs were removed using a front-end loader. During this process, the outlines for the dowel slots in the adjacent panels were also cut. This concrete was later carved out using pneumatic jackhammers. Figure 4 illustrates the slab sawing and removal process.

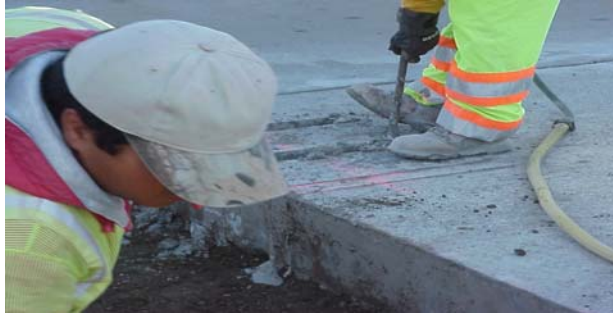
a) Jackhammering of dowel slots.

As shown in Figure 6, there are three dowel bars in each wheelpath. The dowel slot cutting and preparation include initial grooving to the required depth with a concrete saw; jackhammering of the concrete to carve out the dowel slot; air cleaning of dowel slot to remove debris and any loose concrete pieces; and sandblasting of the dowel slots. The dowel slots were approximately 100 mm (4 in.) wide and 133 mm (5.25 in.) deep (base of the slot cut). Figure 6 illustrates the slot cutting and preparation process.

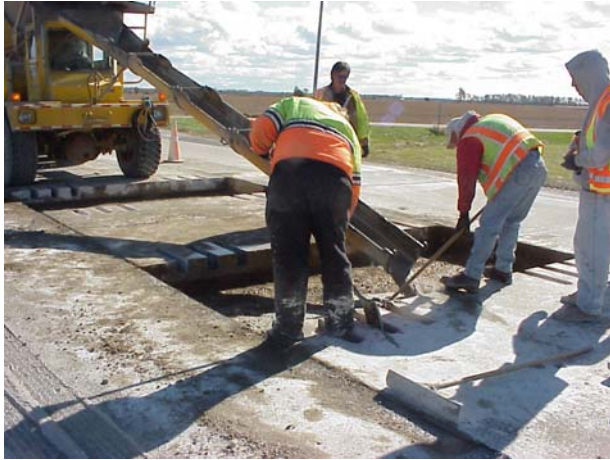
a) Placing of flowable fill.

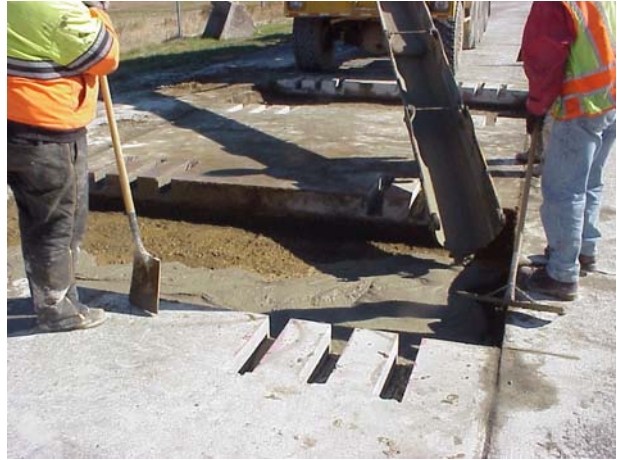
b) Leveling of flowable fill.

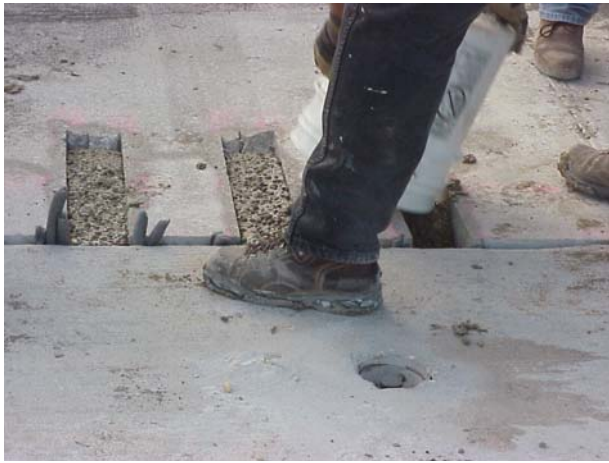
c) Back filling of dowel slots.

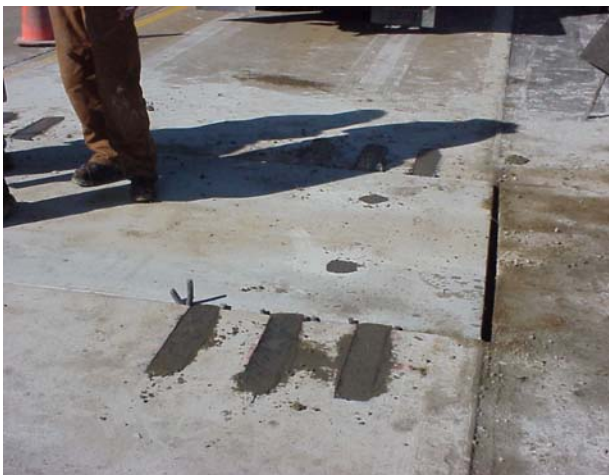
d) Back-filled dowel slots.

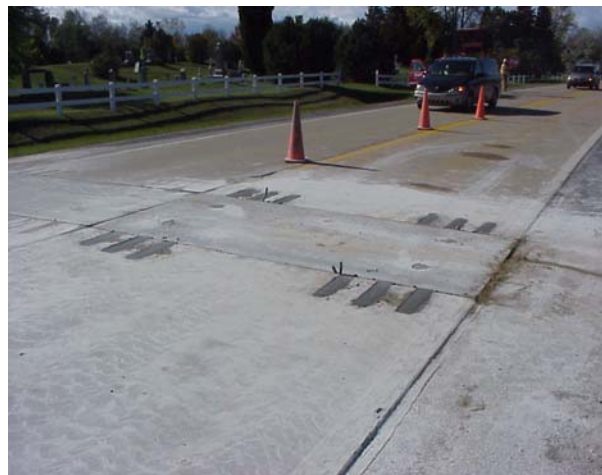
e) Completed panel.

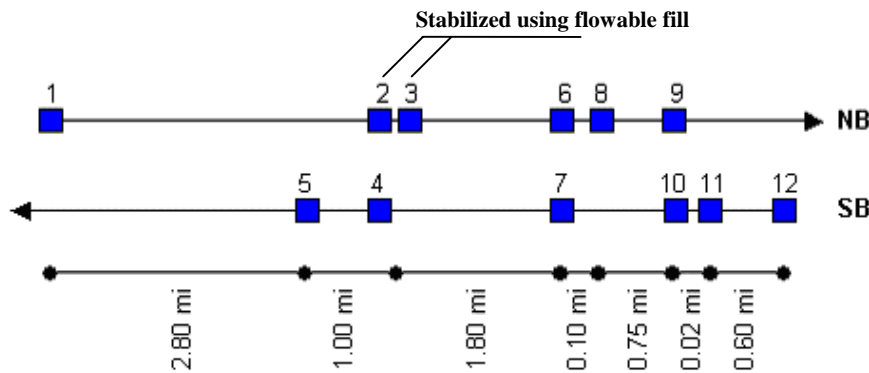
Figure 12. Relative distances of patches along the M-25 project.

At the M-25 project site, 12 precast panels were installed over a period of 3 days. Contributing to the longer installation time were the distances between some of the panels and the construction interruptions due to rain. Figure 12 illustrates the relative location of the precast panels.

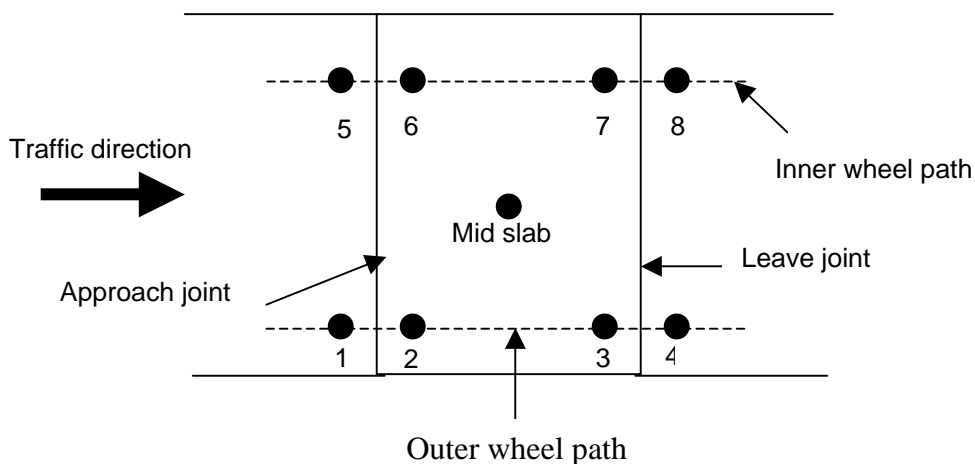
Figure 14. Falling-weight deflectometer test locations to evaluate panel effectiveness.

The repair effectiveness of the panels was determined by conducting distress surveys and falling-weight deflectometer (FWD) tests according to the protocol illustrated in Figure 14. Test locations 1 through 8 allowed for the computation of load transfer efficiency (LTE) across the approach and leave joints. The LTE was computed using the following equation, where LTE:

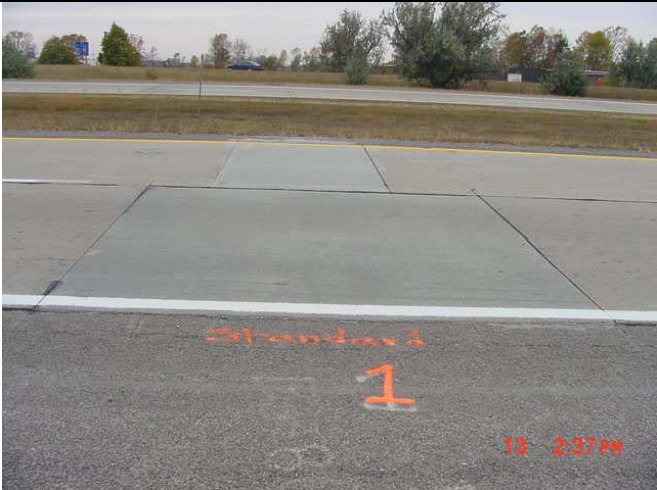
<p>Panel 1</p>	<p>There is no evidence of distress. The average LTE ranges from 81% to 89%, and the deflection ratios are less than 2.5.</p> <p style="text-align: right;"><i>continued</i></p>

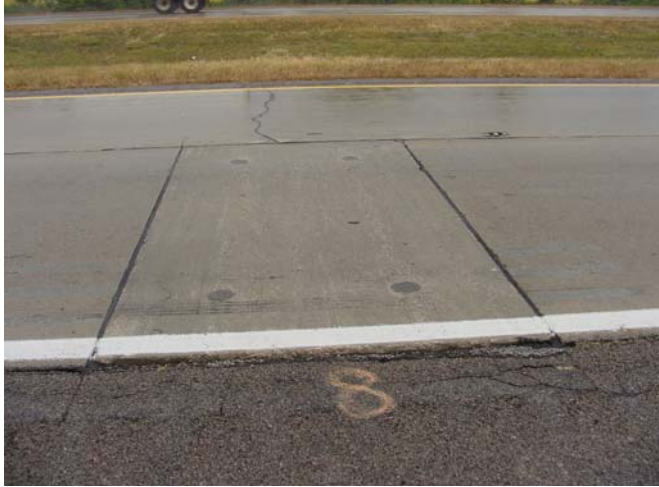
<p data-bbox="479 768 560 793">Panel 8</p>	<p data-bbox="875 501 1406 590">The panel is in good condition. The average joint LTE ranges from 73% to 80%, and the deflection ratios are less than 2.</p>

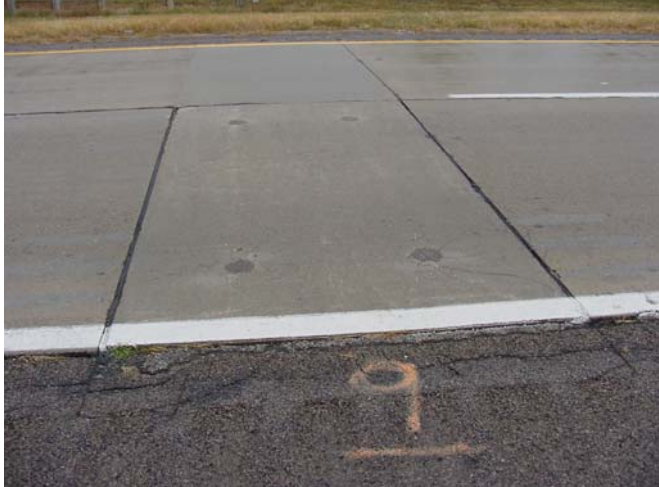
<p data-bbox="479 1299 560 1325">Panel 9</p>	<p data-bbox="875 1022 1406 1140">The panel is in good condition. A high spot was observed at one end of the repair. The average joint LTE ranges from 77% to 84%, and the deflection ratios are less than 2.</p>

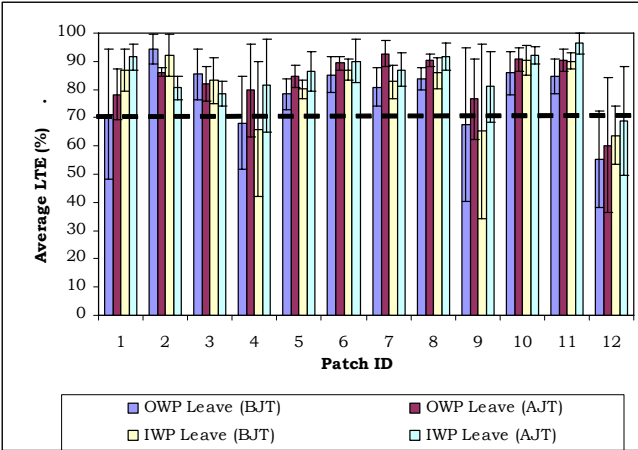
(a) Leave slab loading.

The FWD results are presented in Figure 16 (a) through (c). The dashed lines represent the minimum LTE threshold of 70 percent and a deflection ratio threshold of 3 for doweled joints. On average, the approach and leave LTEs are in excess of 70 percent (the average LTEs range from 72 percent to 90 percent) as shown in Figure 16 (a) and (b) and Table 8. Figure 16 (c) represents the relative deflections (peak) of the joint with respect to the mid-slab deflection (peak). The approach joint deflection ratios range from 1.2 to 2.3, whereas the leave joint ratios range from 1.0 to 3.0, indicating an acceptable support under the panel.

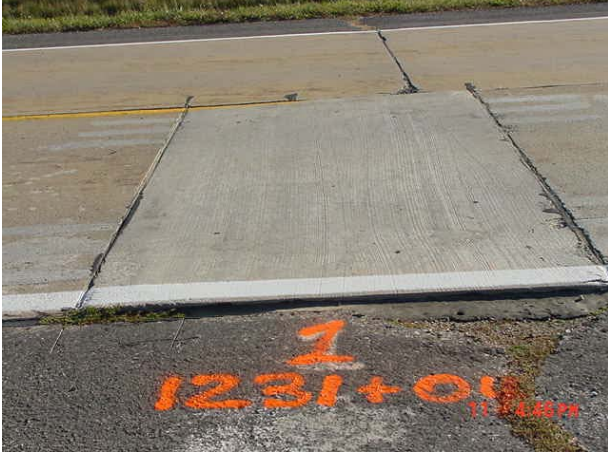
<p data-bbox="472 873 553 898">Panel 1</p>	<p data-bbox="846 617 1430 705">The panel is in good condition. The average joint LTE ranges from 82% to 85% and the deflection ratios are less than 2.</p>

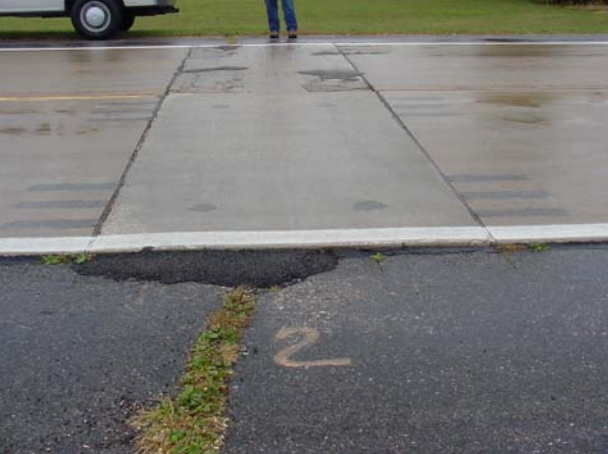
<p data-bbox="472 1356 553 1381">Panel 2</p>	<p data-bbox="846 1058 1430 1176">The panel is in good condition. The average joint LTE ranges from 88% to 92% and the deflection ratios are less than 2. The panel was stabilized using flowable fill.</p> <p data-bbox="1305 1335 1430 1360" style="text-align: right;"><i>continued</i></p>

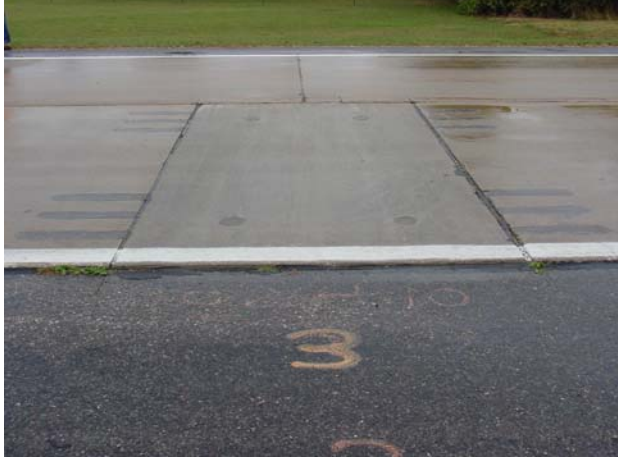
<p data-bbox="493 726 574 751">Panel 3</p>	<p data-bbox="889 457 1421 575">The panel is in good condition. The average joint LTE ranges from 82% to 88% and the deflection ratios are less than 2. The panel was stabilized using flowable fill.</p>

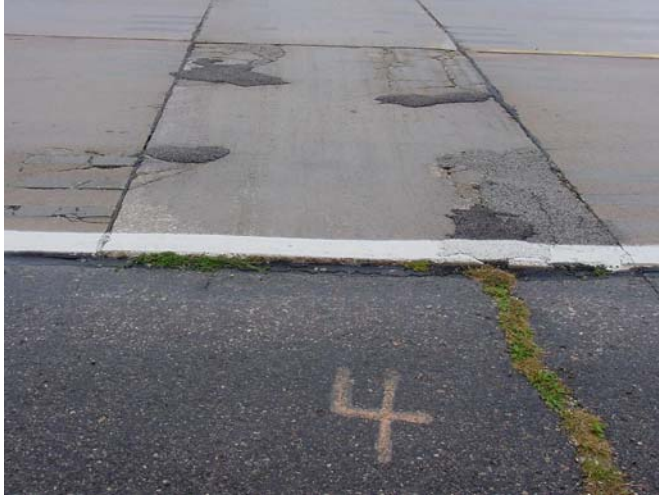
<p data-bbox="493 1266 574 1291">Panel 4</p>	<p data-bbox="889 951 1409 1127">The repair is severely deteriorated. The cracking along the dowels was first observed during the summer of 2004. The cracking was observed along the approach and leave joint of the panel. The average joint LTE ranges from 73% to 78% and the deflection ratios are less than 2.</p>

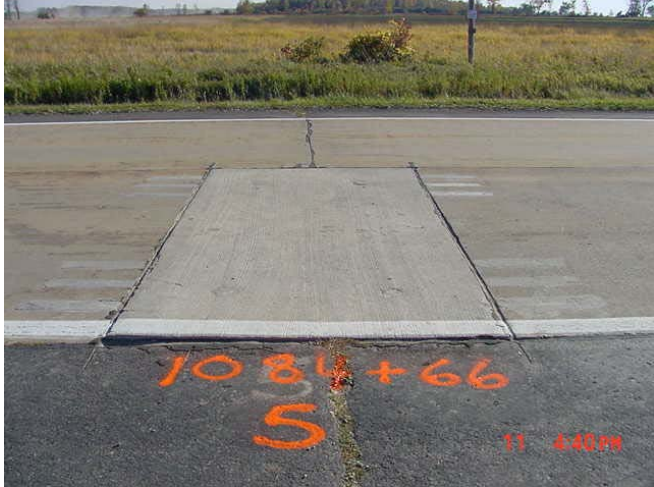
<p data-bbox="493 1797 574 1822">Panel 5</p>	<p data-bbox="889 1520 1421 1604">The panel is in good condition. The average joint LTE ranges from 82% to 88% and the deflection ratios are less than 2.</p> <p data-bbox="1328 1730 1430 1755" style="text-align: right;"><i>continued</i></p>

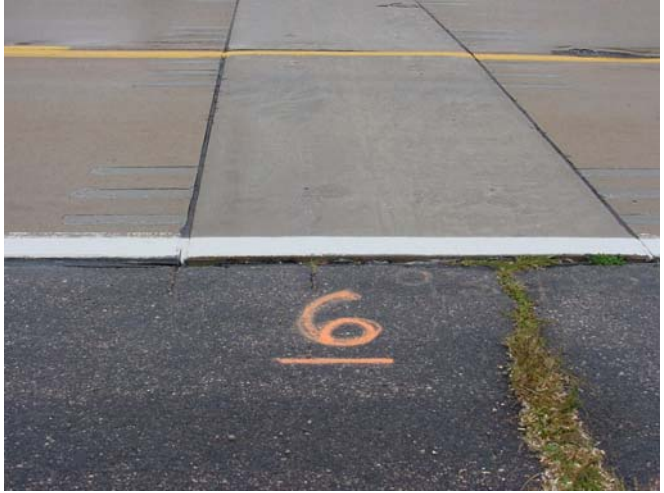
<p data-bbox="472 758 558 785">Panel 6</p>	<p data-bbox="870 491 1406 579">The panel is in good condition. The average joint LTE is 88% and the deflection ratios are less than 2.5.</p>

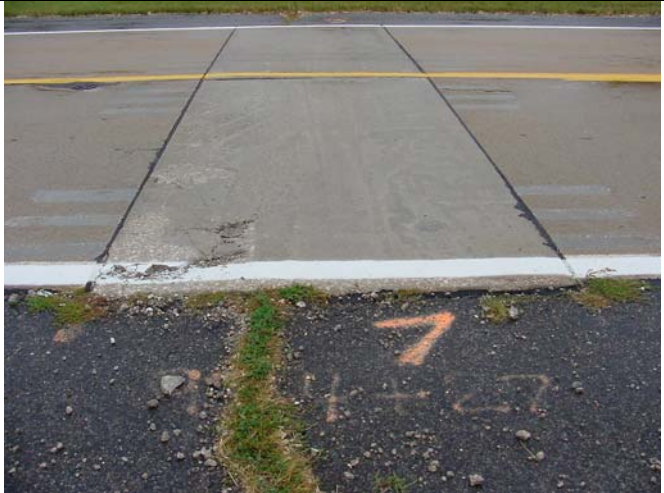
<p data-bbox="472 1325 558 1352">Panel 7</p>	<p data-bbox="870 1016 1414 1163">The panel is broken in one corner most probably due to snowplow damage, as there was a high spot along the approach joint. The average joint LTE ranges from 86% to 88% and the deflection ratios are less than 2.</p> <p data-bbox="1325 1289 1430 1316" style="text-align: right;"><i>continued</i></p>

3. Diamond grinding of the panel, especially the joints, is recommended to remove high spots. These high spots have a potential to “break off” as a result of snowplowing operations.

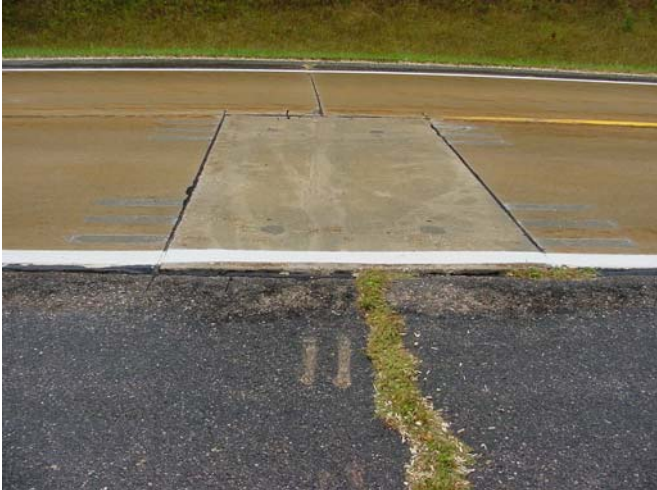
<p data-bbox="467 751 561 783">Panel 11</p>	<p data-bbox="867 506 1425 562">The panel is in good condition. The average joint LTE is 90% and the deflection ratios are less than 2.</p>

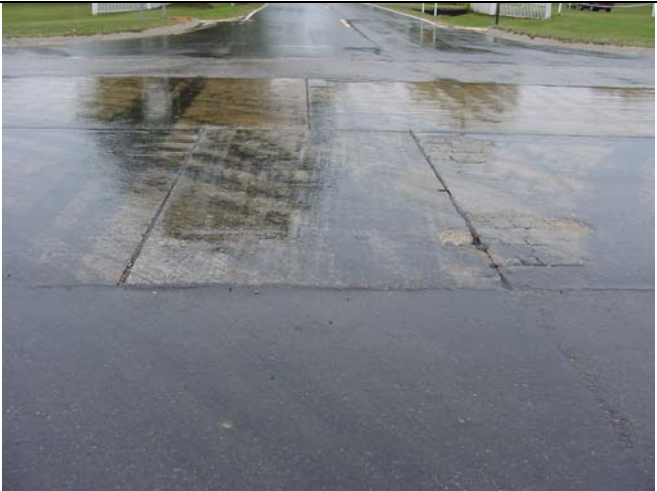
<p data-bbox="467 1323 561 1354">Panel 12</p>	<p data-bbox="867 1014 1435 1199">The panel is in acceptable condition. Trailing edge (leave joint of the panel) broken in the old concrete. The average joint LTE ranges from 62% (leave joint) to 88% and the deflection ratios are less than 2.5. However, the deflection ratio at the broken edge is approaching 3.</p>

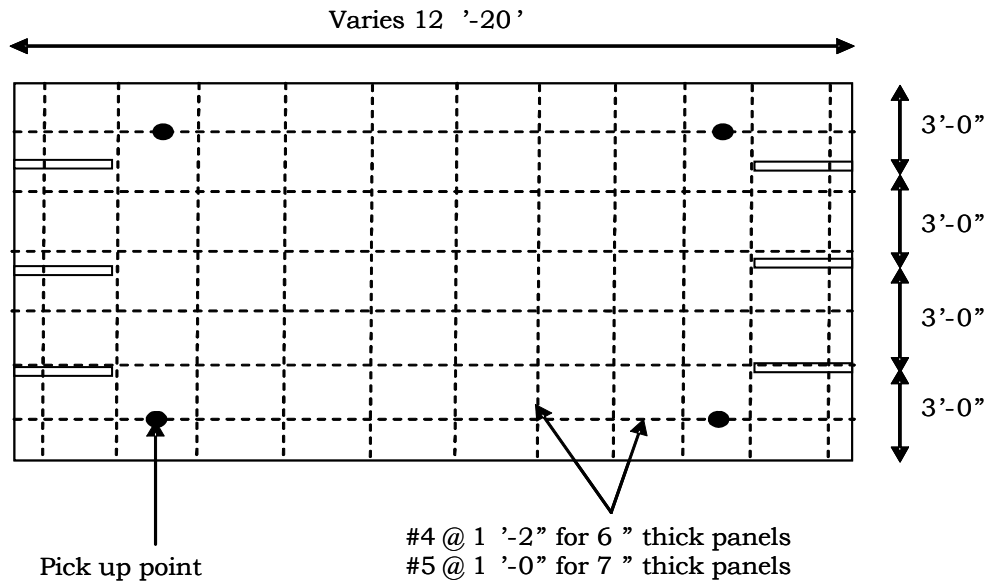
Figure 20. Structural details of the precast panel.

The precast PCC panels were fabricated by the contractor and transported to the project site. The typical structural details of the precast panels are illustrated in Figure 20. The tie bar slots, which were formed during the panel fabrication process, were placed at 0.91 m (3 ft) on center. The panel also consists of #4 or #5 steel depending on the panel thickness. The panel lengths were variable so as to match the contraction joint spacing. The typical PCC mixture designs for this study are summarized in Table 11, and the compressive strength data for the Mead and Loveland sites are summarized in Table 12.

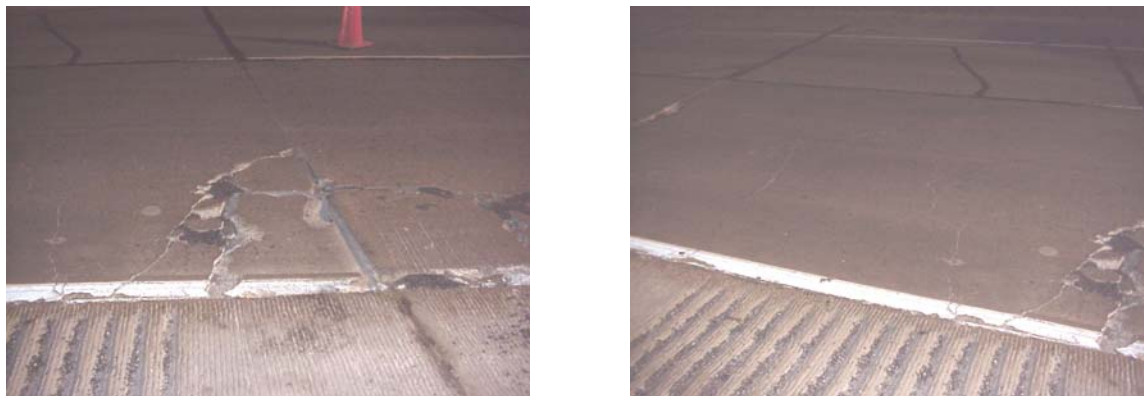
Figure 21. Examples of distresses.

Prior to the removal of the candidate panels a distress survey was conducted. Typical distresses observed during the survey included midpanel transverse cracks with associated spalling; joint sealant damage, spalling, and asphalt patch deterioration; and corner cracking. Some examples of distresses are shown in Figure 21.

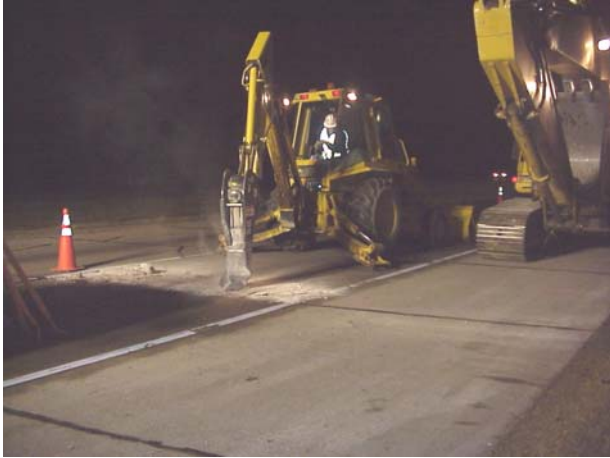
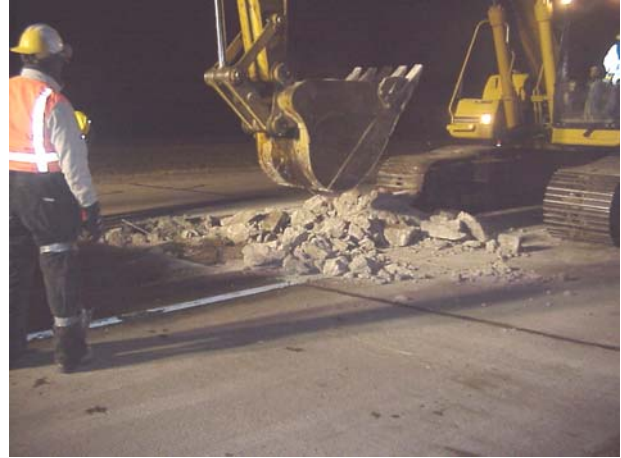
a) Slab demolition

b) Removal of debris

Figure 22. Slab demolition process.

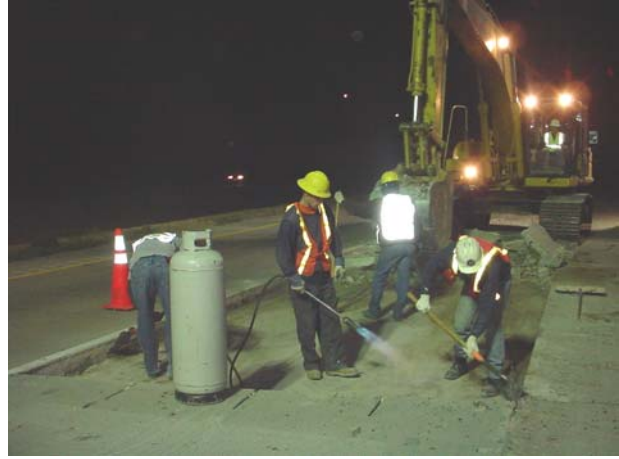
Figure 23. Base preparation activities.

The exposed base was swept and cleaned using compressed air. In addition to the cleaning, the base and joint edges were dried (to remove any traces of moisture) using a hot-air lance. A secondary effect of using the hot-air lance was to expedite the curing of the slab-jacking foam. Figure 23 illustrates the base preparation activities.

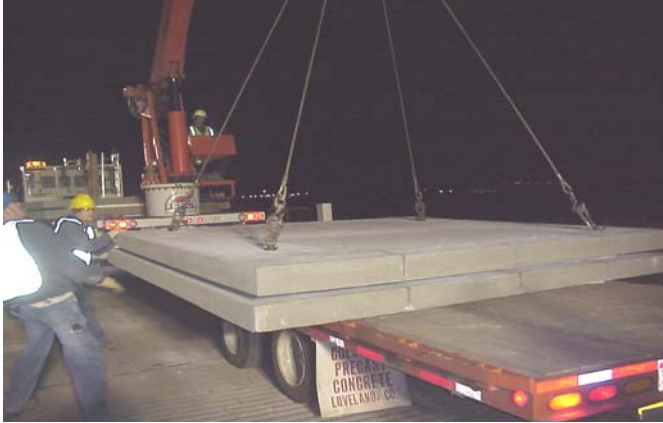
a) Panel moved from flatbed truck.

The panels were brought to the site on a flatbed truck and lowered into the excavation using a 133-kN (30-kip), truck-mounted crane. Figure 24 illustrates the panel placement process.

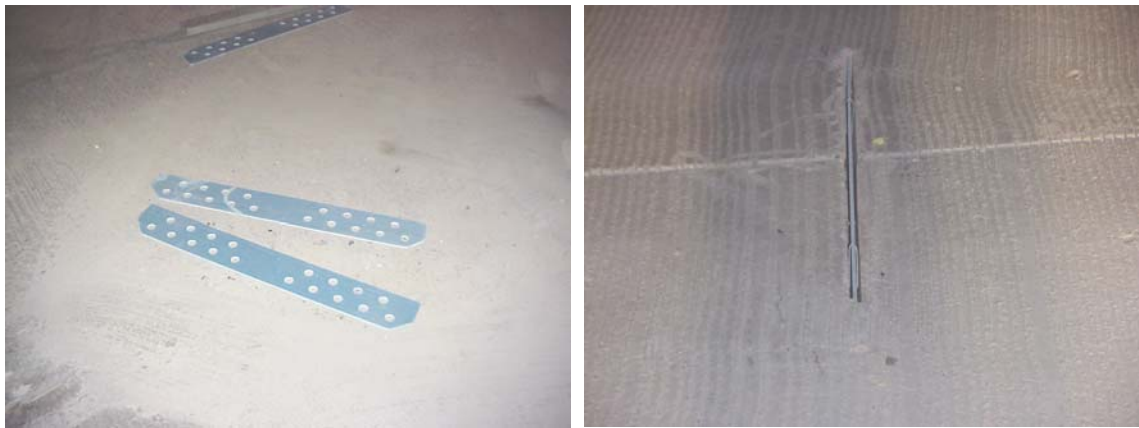
Figure 25. Fiberglass stitches.

The fiberglass stitches were placed into the 19-mm (0.75-in.) slot using two guides wire spacers, one at each end. The fiberglass ties are 0.9 m long, 127 mm wide, and 6 mm thick (36 in. long, 5 in. wide, and 0.25 in. thick). A picture of the tie bar is shown in Figure 25.

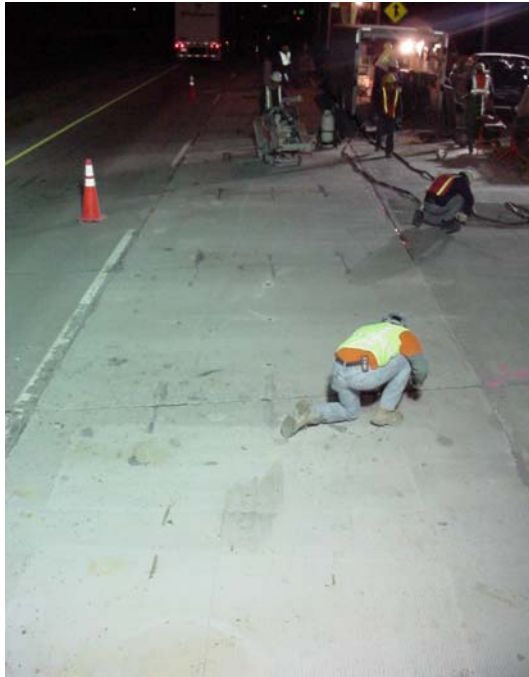
Figure 26. Completed cluster of panels.

The injection ports were sealed using a nonshrink grout. The procedure included drilling out leftover jacking foam; cleaning the surface of the concrete for proper adhesion; and placing the grout. Figure 26 illustrates a cluster of completed panels.

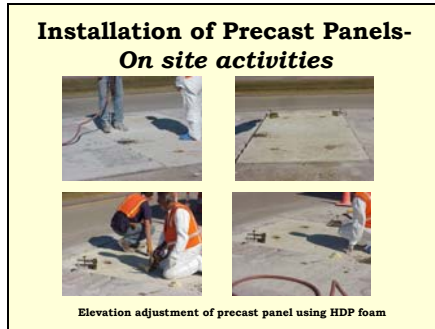
A series (approximately 4–6 holes/panel) of holes (5/8" in diameter) are drilled to inject the foam. The polyurethane foam is made from two liquid chemicals that combine under heat to form a strong, lightweight, foam-like substance. The chemical reaction between the two materials causes the foam to expand and fill the voids. According to the manufacturer's specification, the HDP foam sets in approximately 15 minutes (approximately 90% of full compressive strength), and the precast panel is ready to carry load. For the purpose of slab stabilization, the foam density is about 4 lbs/ft³ with a compressive strength range of 60 psi to 145 psi.
